**Subject: LaChausse Dam – Inventory Number TX03755
Tyler County, Texas**

Dam Safety Inspection Report

LaChausse Dam – TX03755

INSPECTION DATE: July 18, 2012

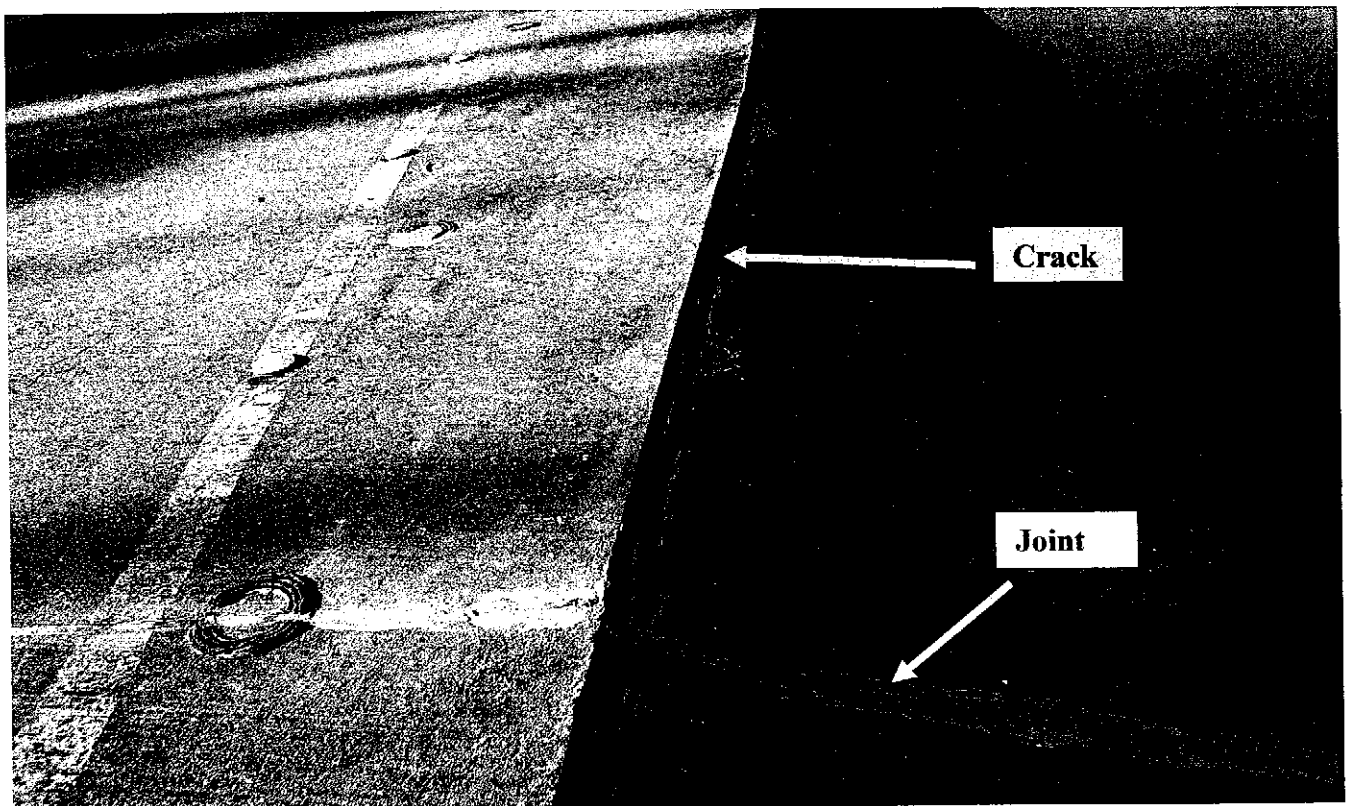
Photo 3. Upstream slope. View is looking south from the left end of the dam. An open joint was present between the dam crest and upstream slope along the entire length of the embankment. Additionally, the sealant in the joints between the concrete panels on the slope was deteriorated.

3. As recommended in the 2004 and 2007 inspection reports, the interface between the upstream slope pavement and the dam crest needs to be repaired. A Texas licensed professional engineer should inspect the interface and develop plans for repair. Any plans for repair of this area must be approved by TCEQ Dam Safety Section staff prior to initiating the repairs and be implemented under the supervision of your Texas licensed professional engineer.

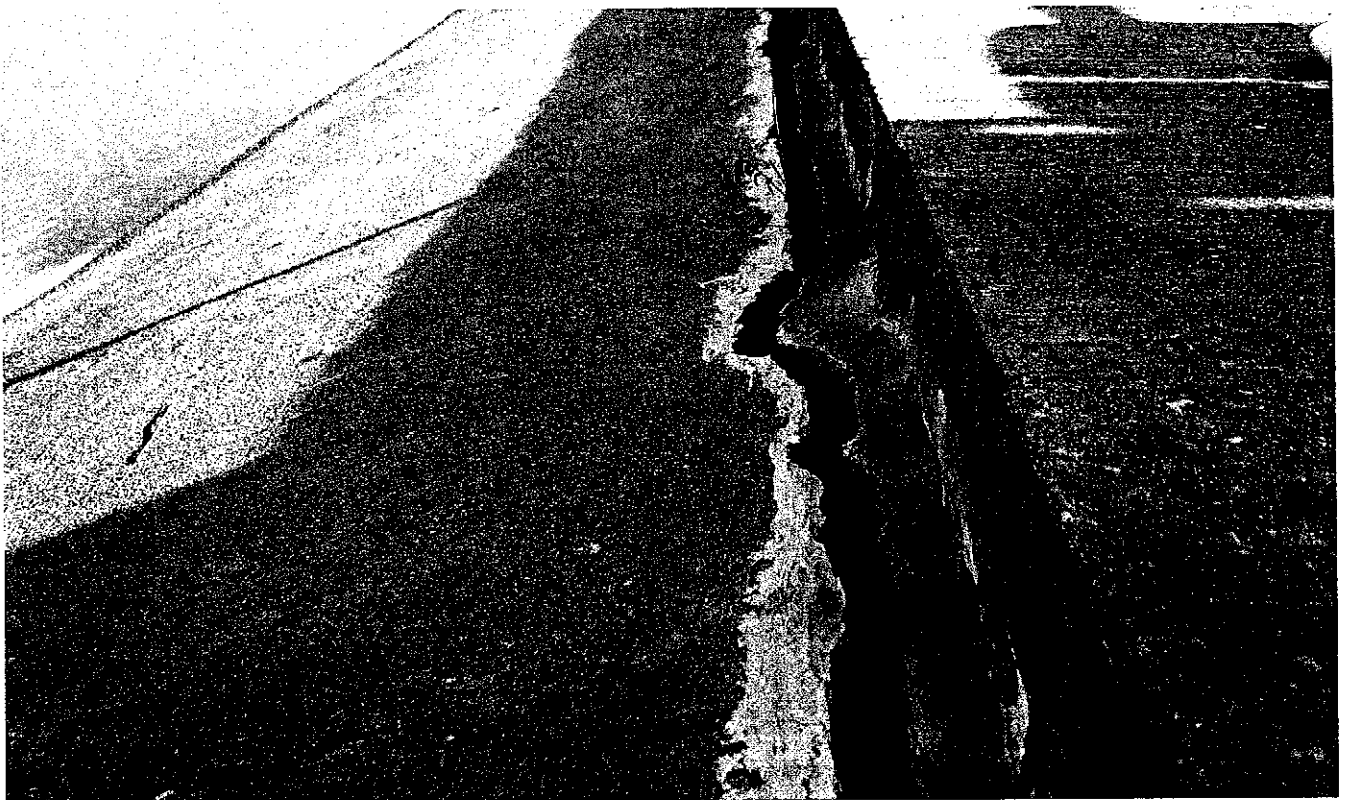
Photo 4. Upstream slope. View is of the open joint between the dam crest and upstream slope. The joint was a maximum of approximately 2.5 inches wide and 4.5 inches deep. Also a small crack with no displacement was present in the concrete panel.

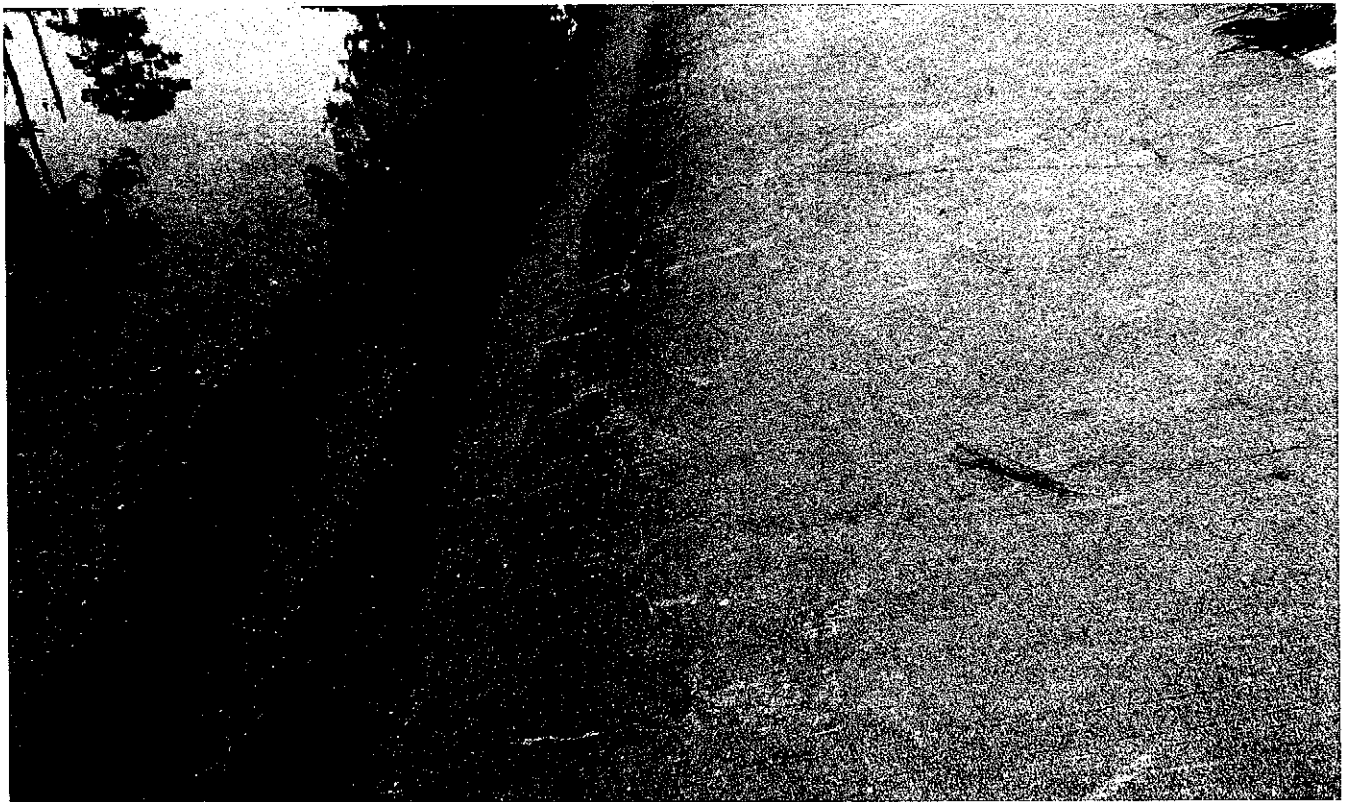
Photo 7. Upstream slope. View is of cracks in the upstream slope's concrete cover

4. As recommended in the 2004 and 2007 inspection reports, all joints and cracks in the embankment's concrete cap should be cleaned and resealed with an appropriate elastic sealant.

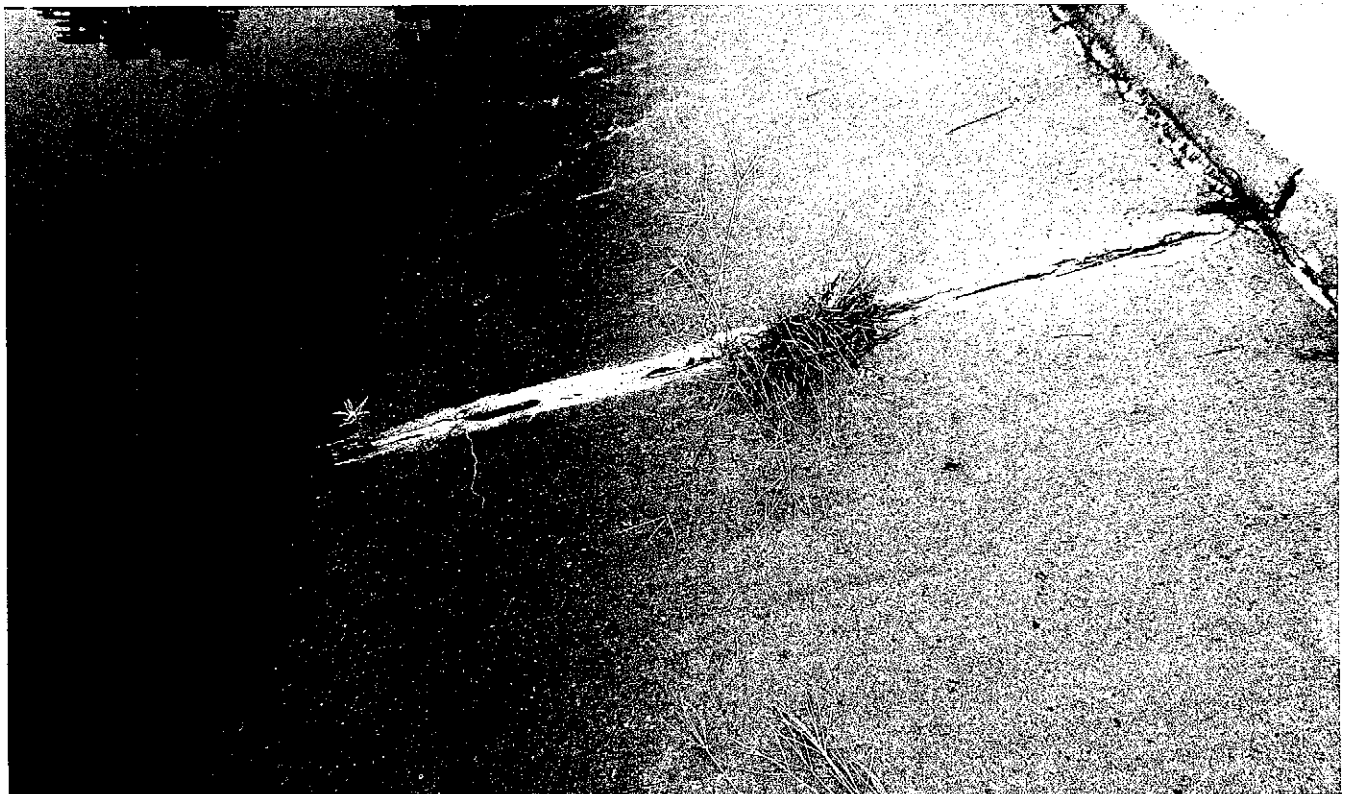
Photo 8. Upstream slope. View is of a joint between concrete panels on the upstream slope. The elastic sealant in the joint was deteriorated and vegetation was growing in the joint.

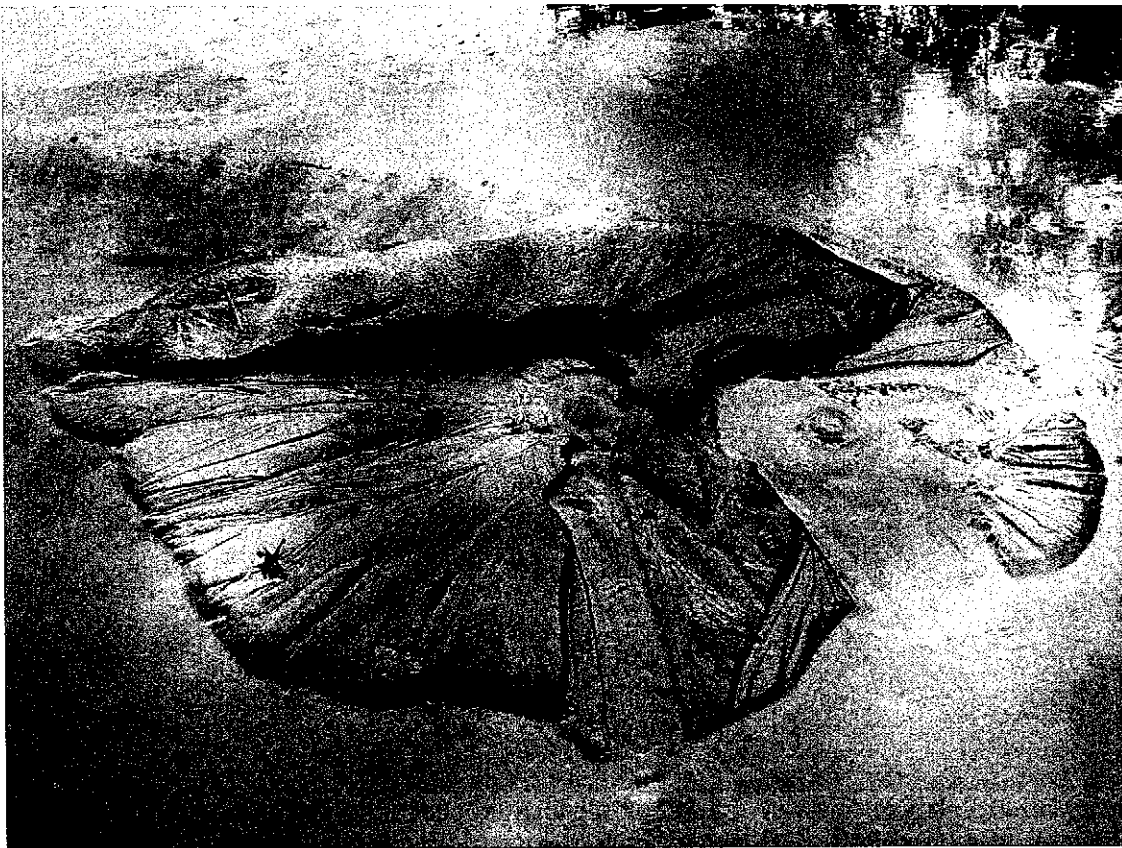
Photo 11. Downstream slope/Stilling basin. View is of one of several active sand boils located in the stilling basin near the right end of the downstream slope.

drain system; bentonite slurry or clay cut-off wall; dewatering wells; or a combination of engineering controls. Any engineering plans to address this issue must be approved by TCEQ Dam Safety Section staff prior to initiating the repairs and be implemented under the supervision of a Texas licensed professional engineer.

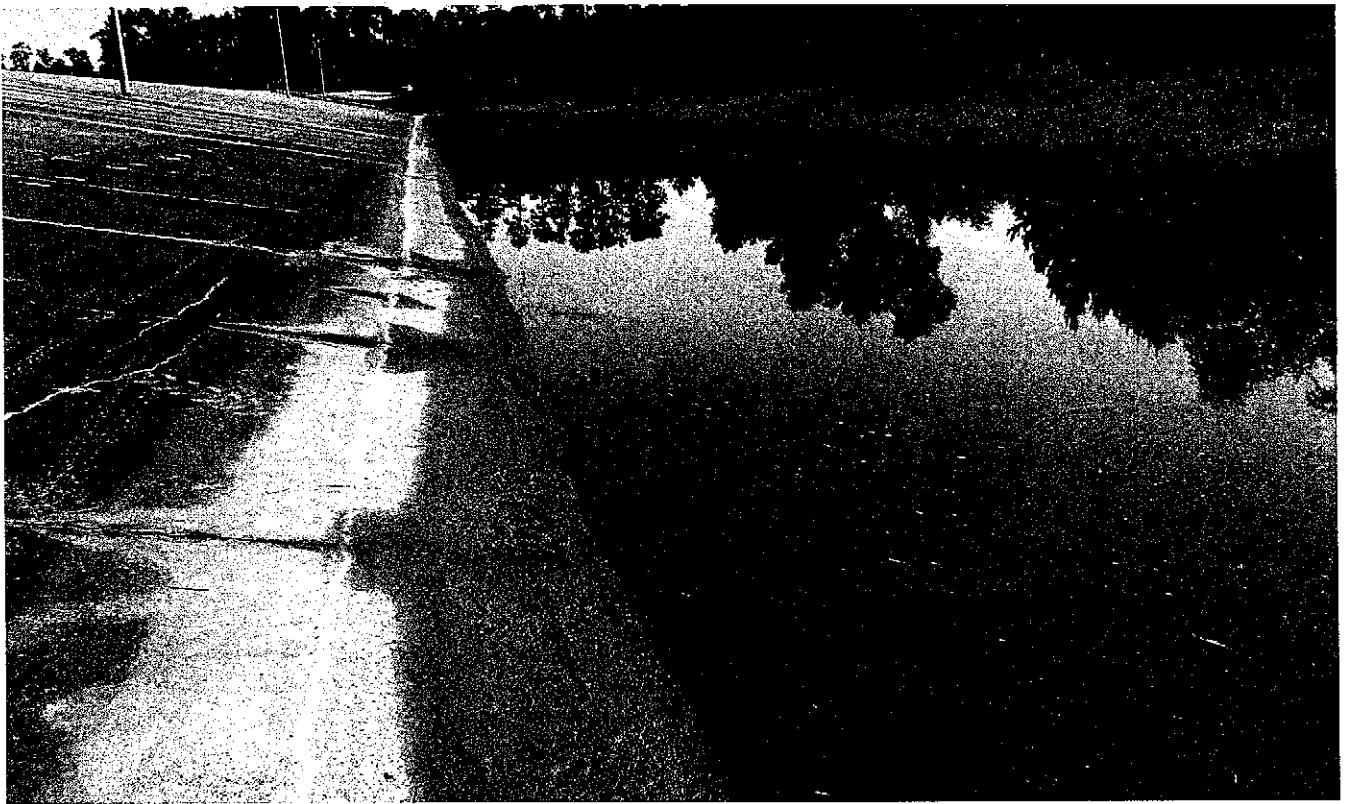
- Some of the joints between the concrete panels on the downstream slope had deteriorated or were missing sealant. Seepage was flowing from some of the joint sections located within 3 feet of the downstream toe of the embankment. Iron staining, sand, and grassy vegetation were present in the seepage areas. The presence of sand in these areas suggests that sediment is being eroded from the embankment. Continued erosion of the embankment could eventually result in failure of the embankment and loss of the impoundment. (Photos 14, 15, 17, 19, and 20)
- Longitudinally oriented cracks were present on the lower portion of the slope. (Photos 14, 19, and 20)
- Metal utility poles were present on the upper portion of the downstream slope. The poles were vertical and showed no signs of downstream slope movement. (Photos 1 and 15)

Photo 15. Downstream slope/Stilling basin. View is looking north from near the right end of the downstream slope. The slope was relatively uniform in grade. Seepage was present along some joints. The utility poles present on the upper portion of the slope were vertical and showed no signs of slope movement.

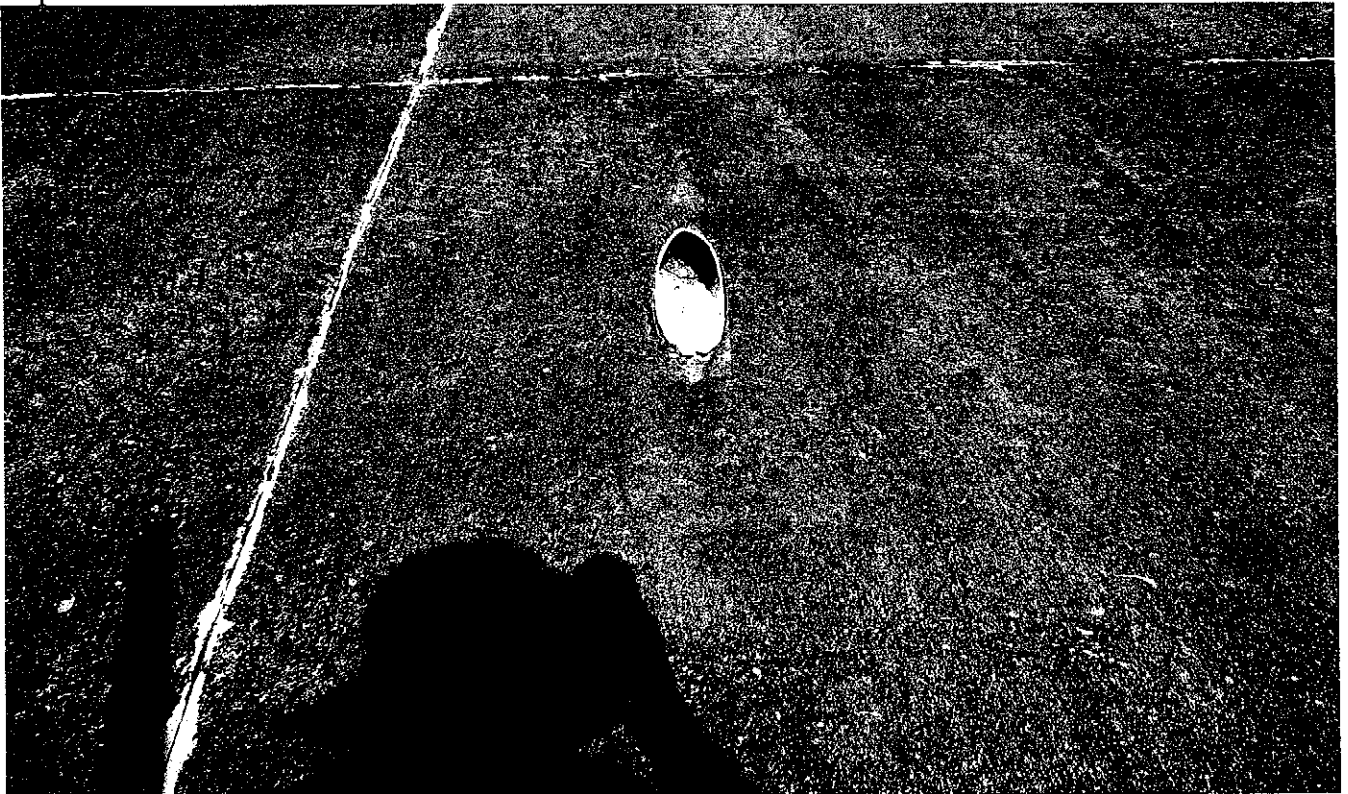
Photo 16. Downstream slope. View is of a sediment filled weep hole near the right end of the downstream slope.

5. All joints and cracks in the principal spillway's concrete cap should be cleaned and resealed with an appropriate elastic sealant.
6. As recommended in the 2004 and 2007 inspection reports, weep holes should be cleared of sediment and vegetation.

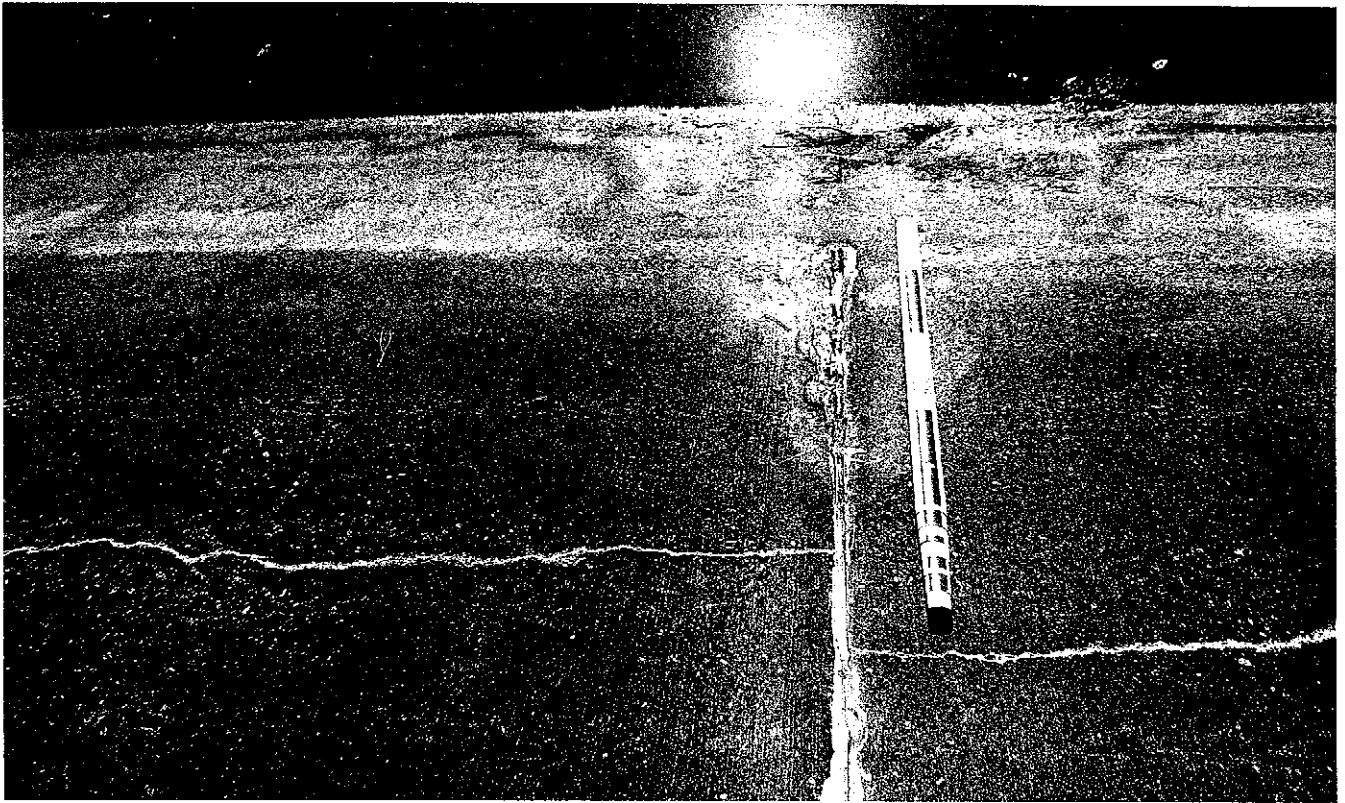
Photo 19. Downstream slope. View is of seepage from a joint on the downstream slope. Note that the seepage was emanating from a point several feet above the downstream toe of the embankment. Longitudinal cracks were present in the embankment's concrete cover.

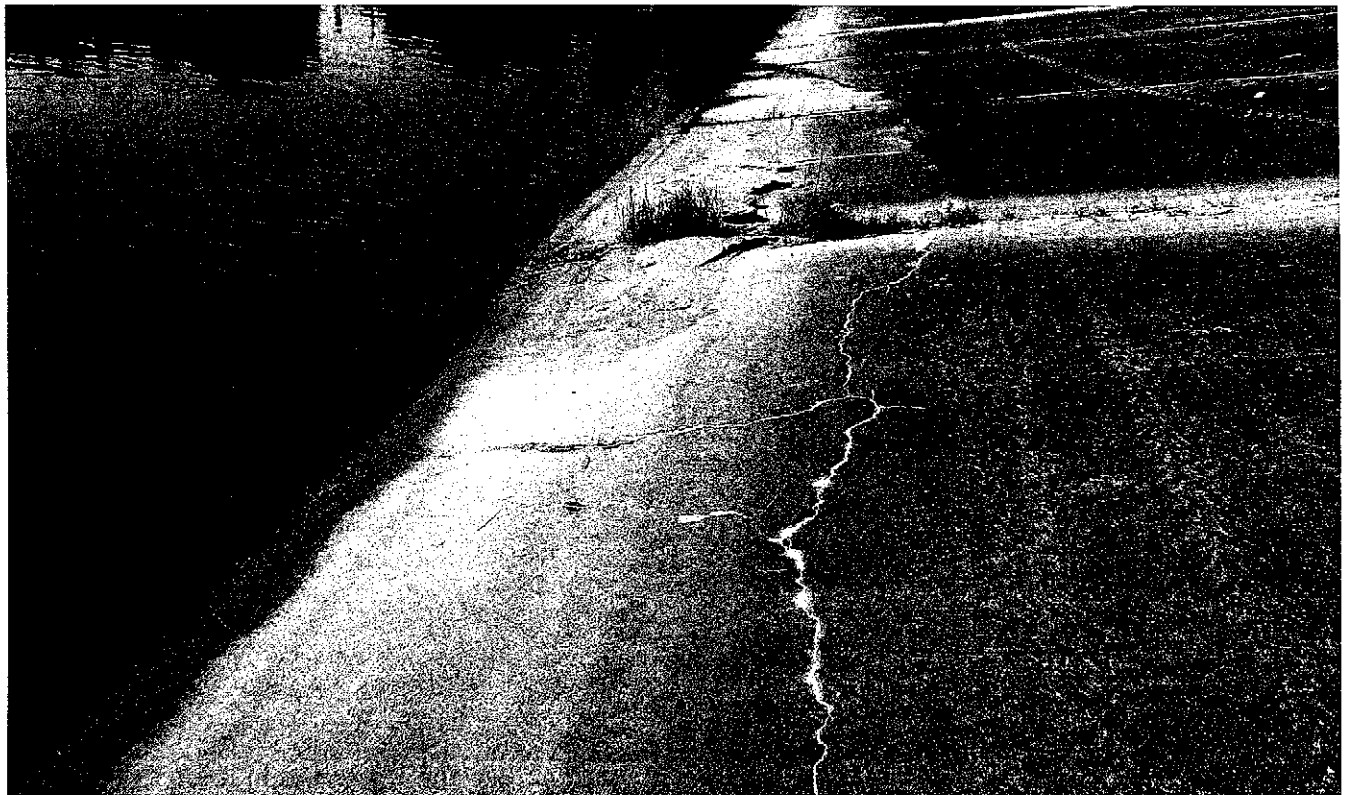
Photo 20. Downstream slope/Stilling basin. View is of longitudinal cracks in the concrete cover and sediment and vegetation in the joints between concrete panels. Sediment was also present in the stilling basin.

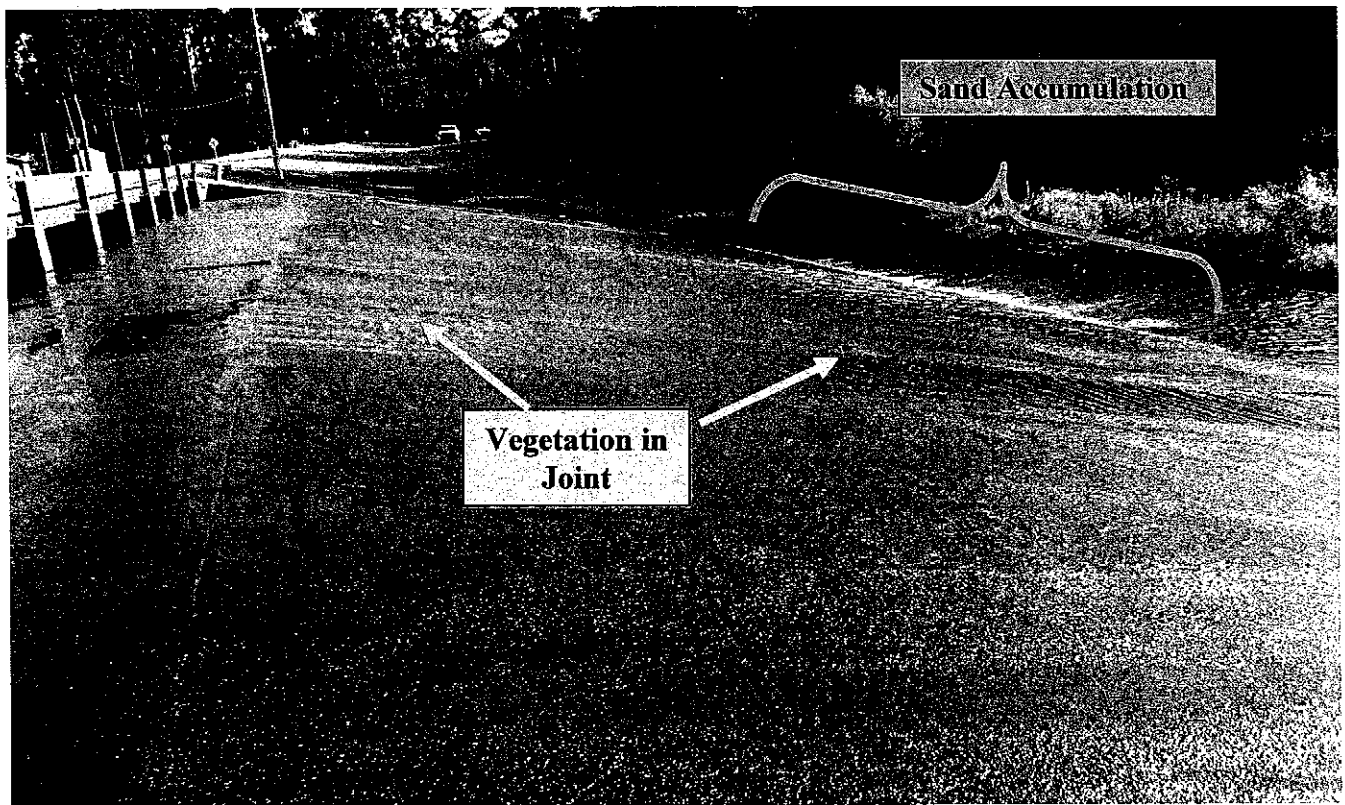
- Some of the joints between the concrete panels on the downstream portion of the spillway had deteriorated or missing sealant. Grassy vegetation was growing in some of the joints. (Photos 23, 24, and 25)

Photo 23. Principal spillway. View is looking north across the downstream side of the principal spillway. The spillway was engaged. Vegetation was growing in the joint where noted. Note the areas of accumulated sand along the downstream toe.

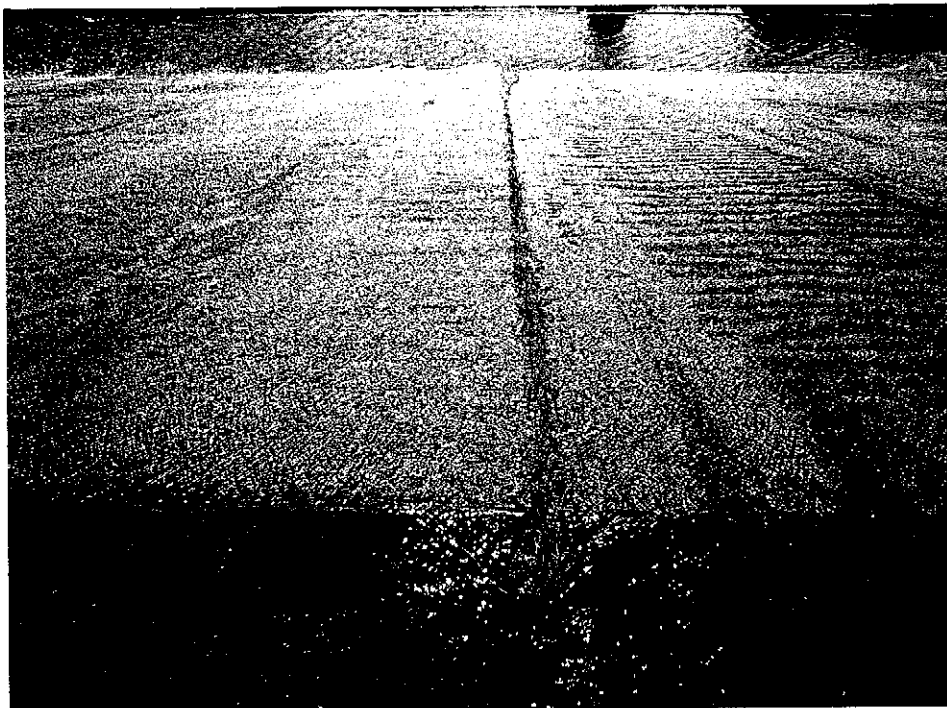
Photo 24. Principal Spillway. View is of a joint with vegetation on the spillway discharge area. Note the areas of accumulated sand along the downstream toe.

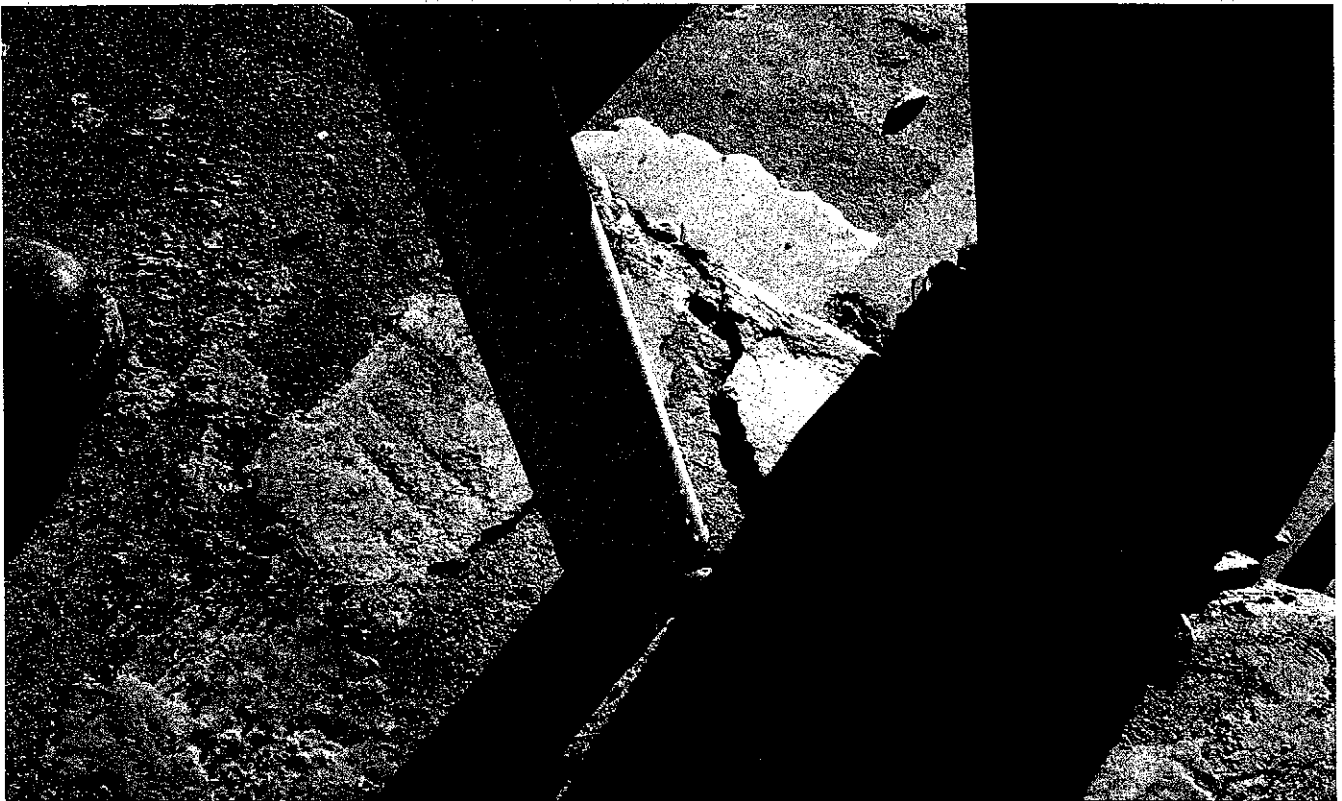
- The top of the spillway's box culverts supports a two lane concrete roadway (Camelot Drive) with metal guardrails and posts. The concrete at the base of some of the guardrail posts was cracked and spalled. (Photos 22 and 27)

Photo 27. Principal Spillway. View is of cracked and spalled concrete at the base of a guardrail post secured to the bridge over the principal spillway. This photo is representative of the condition of many other guardrail posts on the bridge.

7. As recommended in the 2004 and 2007 inspection reports, spalling and cracks in the concrete at the base of guard rail posts should be repaired.
8. As noted in the 2004 and 2007 inspection reports, a Texas licensed professional engineer should evaluate and develop plans for repair of the cracked and spalled concrete in the principal spillway's right sidewall.
